**Flood Control Project Maintenance
Levee Inspections**

Maintenance Issue Types Only, Levee Inspection Report By Mile - Spring 2019

Sutter Maintenance Yard Maintenance Area 0013

Waterway	Bank	Unit Miles	Inspection Start/End	Inspector
Unit No. 01 Cherokee Canal	Right	18.19	05/15/2019 05/15/2019	Makar Sokol

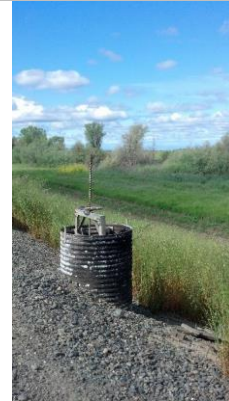
Photo 2 of 3 : UCIP_SP_2019_52154_67337.jpg

Stand pipe with screw gate WS

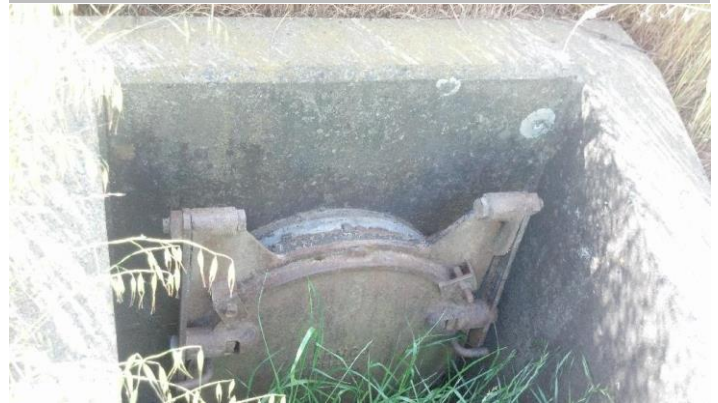
Photo 3 of 3 : UCIP_SP_2019_52156_67342.jpg

View of WS headwall and flap gate.

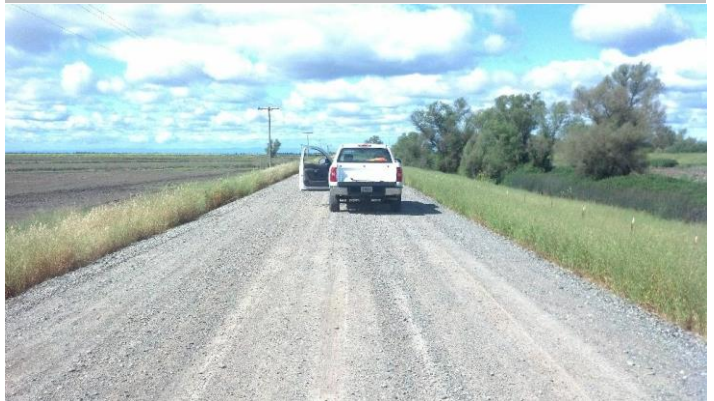
Photo 1 of 3 : UCIP_SP_2019_52157_67352.jpg

FS_ID:52157
DS_ID:16382
EP_NO: N/A
Repair Type: Non-Urgent
Crossing Status: Found
UCIP Comments: 5/30/2017 LS pipe end is buried and location unknown. WS flap gate bolted shut. Pipe has been selected to be internally cleaned and inspected as part of the DMP project. (DWR Sutter Yard- AFreitag)11/17/2016 Unable to locate LS pipe end. WS flap gate bolted shut. (DWR Sutter Yard- AFreitag)4/26/2016 Appears to be an abandoned crossing. LS pipe end was still buried and WS flap gate was bolted shut.6/30/2015 LS headwall stil buried somewhere. WS looked to be in good condition.5/28/2014 Same as last inspection.12/4/2013 Same as last inspection.7/08/2013 Same as last inspection.4/24/2012 LS headwall buried. Limited inspection on WS and LS slopes due to dense vegetation. Need photos of cleared WS and LS slopes during next inspection. Need to determine the fate of LS headwall. This crossing was listed in the USACE Periodic Inspection report as Corp's inspect ID# USACE_CESPK_M13E_2011_p_0022 -- unknown issue.

Overview of crossing looking downstream of the left bank of Cherokee

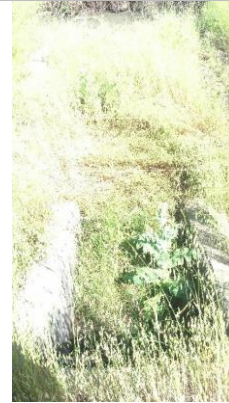
Photo 3 of 3 : UCIP_SP_2019_52157_67350.jpg

View of WS headwall.

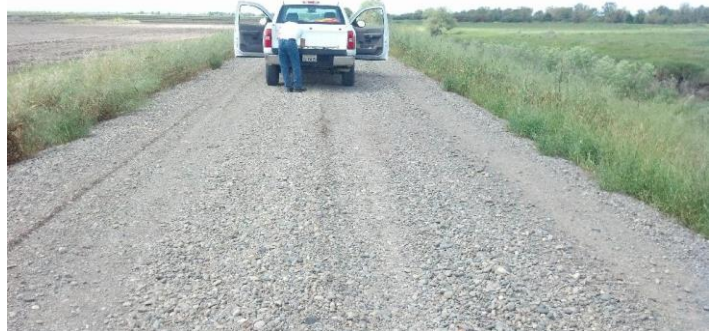
Photo 1 of 3 : UCIP_SP_2019_52161_67387.jpg

Overview of crossing looking D/S at left bank of Cherokee Canal.

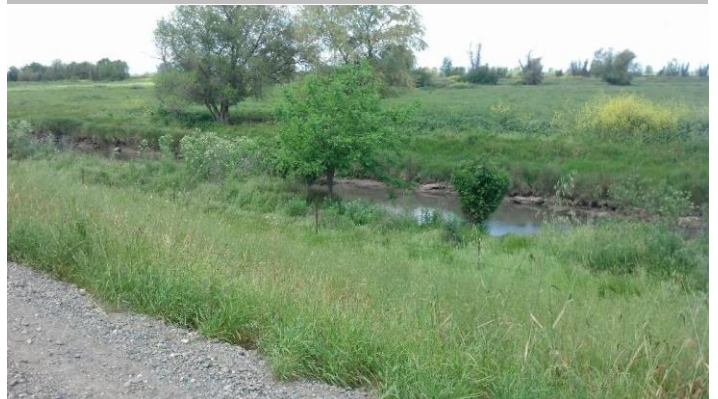
Photo 2 of 3 : UCIP_SP_2019_52161_67386.jpg

View of WS slope and berm.

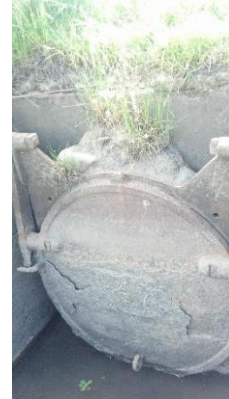
Photo 3 of 3 : UCIP_SP_2019_52161_67390.jpg

View of flap gate located on WS.

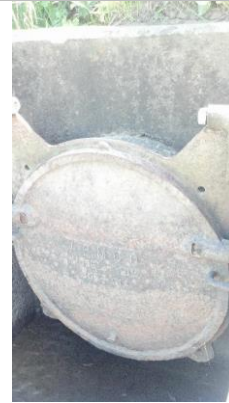
Photo 3 of 3 : UCIP_SP_2019_52164_67402.jpg

Item	DWR UCIP LMA Responsibility			39.378198 °	39.378198 °	
				-121.838570 °	-121.838570 °	
DWR ID	16375					
Comment Code						
Inspector Comment						
FS_ID:52164 DS_ID:16375 EP_NO: N/A Repair Type: Non-Urgent Crossing Status: Found UCIP Comments: 5/30/2017 Erosion still present at WS headwall. Pipe has been selected to be internally cleaned and inspected as part of the DMP project. (DWR Sutter Yard- A Freitag)11/17/2016 Erosion still present at WS headwall. (DWR Sutter Yard- A Freitag)4/26/2016 Erosion still present behind the WS headwall. The rest of the crossing appears in good condition.6/30/2015 Erosion still present behind the WS headwall. Everything thing else with the crossing appeared to be in good condition.12/4/2013 Same as last inspection.5/28/2014 Same as last inspection.7/08/2013 Erosion problem same as last inspection. WS and LS slopes have been cleared of vegetation and are in good shape.4/24/2012 Erosion present behind WS headwall. Limited inspection on WS and LS slopes due to dense vegetation. Need photos of cleared WS and LS slopes during next inspection. FIELD_STRUCT_DESC: 30-inch corrugated metal drainage pipe through the levee, 13.1 feet below the crown. Flap gate on the waterside (WS) end. Concrete "U" headwalls on both WS and landside (LS). [Additional Reference(s): DWR Levee Log, 1993. USACE Sacramento O&M Manual 519, June 1962 (HLM 20.15)] FS Date: 6/8/2017 10:23:50 AM

Flap gate located on the WS.

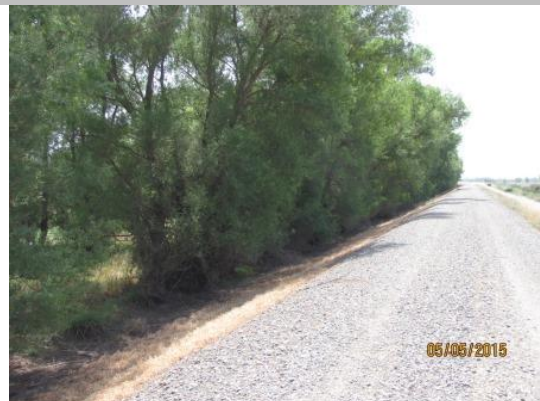
Photo 1 of 1 : SP_2019_MA0013_301_6_20190327_00002.jpg

LM Start	20.43	Rating **	M	Issue No.	6
LM End	20.74	Issue Type +	Ma	Location *	LS
Category	Earthen Levee			GPS Latitude/Longitude	
				Start	End
Item	Trim / Thin Trees			39.373091 °	39.370795 °
				-121.845225 °	-121.850124 °
DWR ID	DWR_MA0013_02_s_2013_6				
Comment Code					
T1 : Trim trees to at least five feet above ground level.					
Inspector Comment

View of the overgrown trees along the landside slope.

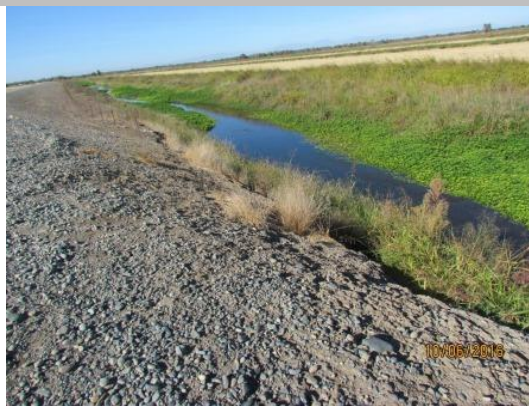
Photo 1 of 1 : SP_2019_MA0013_301_75_20190327_00018.jpg

LM Start	20.77	Rating **	M	Issue No.	75
LM End	20.77	Issue Type +	Ma	Location *	WS
Category	Earthen Levee			GPS Latitude/Longitude	
				Start	End
Item	Erosion / Bank Caving			39.370641 °	39.370641 °
				-121.850572 °	-121.850572 °
DWR ID	DWR_MA0013_02_f_2016_75				
Comment Code					
E2 : Schedule repair of erosion site prior to the next inspection.					
Inspector Comment

View of the erosion along the waterside toe.

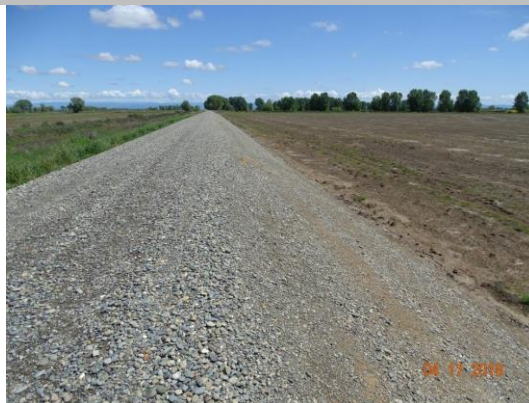
Photo 1 of 1 : SP_2019_MA0013_301_68_20190327_00013.jpg

LM Start	21.03	Rating **	M	Issue No.	68
LM End	21.03	Issue Type +	Ma	Location *	LS
Category	Earthen Levee			GPS Latitude/Longitude	
				Start	End
Item	Animal Control			39.368682 °	39.368682 °
				-121.854817 °	-121.854817 °
DWR ID	DWR_MA0013_02_s_2018_68				
Comment Code					
A3 : No rodents visible, but rodent burrows visible; need to backfill and compact or grout burrows.					
Inspector Comment

View of the rodent holes along the landside slope.

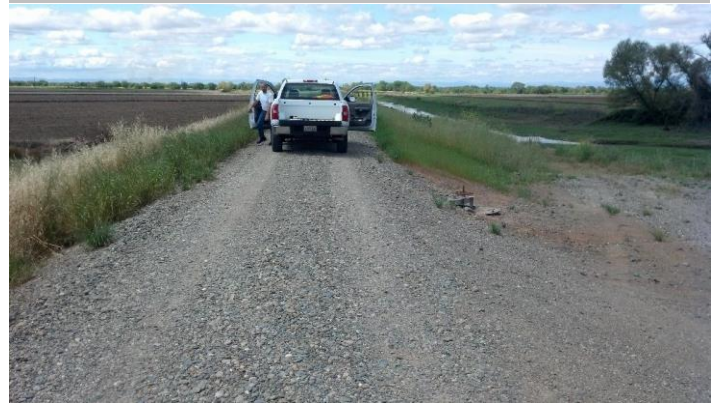
Photo 1 of 3 : UCIP_SP_2019_52168_67447.jpg

FS_ID:52168
DS_ID:16384
EP_NO: N/A
Repair Type: Non-Urgent
Crossing Status: Found
UCIP Comments: 5/30/2017 Crossing appears to be in good condition. Pipe has been selected to be internally cleaned and inspected as part of the DMP project. (DWR Sutter Yard - A Freitag)11/17/2016 Pipe section that crosses through the levee appears to be in good condition. (DWR Sutter Yard - A Freitag)4/26/2016 Pipe appears to have been repaired. Not sure on the extent of the repairs or if they were approved by the Central Valley Flood Control Board.6/30/2015 Pipe is currently undergoing repairs. Not sure what all is planned to be fixed but will update the photos and inspection report with new details when its completed.5/28/2014 Same as last inspection.12/4/2013 Same as last inspection.7/08/2013 Pipe appears to have been repaired. Need to talk to inspections and supervisor to find out more details on repair.4/24/2012 Needs repair. Internal piping, severe corrosion. Debris present--rusted pipe stockpiled on LS slope. Limited inspection on WS and LS slopes due to dense vegetation. Need photos of cleared WS & LS slopes. This crossing was listed in the USACE Periodic Inspection report as Corp's inspect ID# USACE_CESPK_M13E_2011_p_0234 for no WS gate but sluice gate present.

FIELD_STRUCT_DESC: 24-inch corrugated metal drainage pipe through the levee, 8.2 feet below the crown. Crossing penetrates levee at angle. Slide gate in corrugated metal pipe (CMP) riser on the waterside (WS) slope. Pipe crosses the channel. Corroded section of existing pipe, 9-foot and 8-inch of an 18-inch corrugated metal pipe section, was replaced under Permit 7231 prior to 1974. (Permit No. 7231, 1960 - Estate of Walter L. King) [Additional Reference(s): DWR Levee Log, 1993. USACE Sacramento O&M Manual 519, June 1962 (HLM 21.60)]
FS Date: 6/8/2017 10:33:29 AM

Overview of crossing looking downstream.

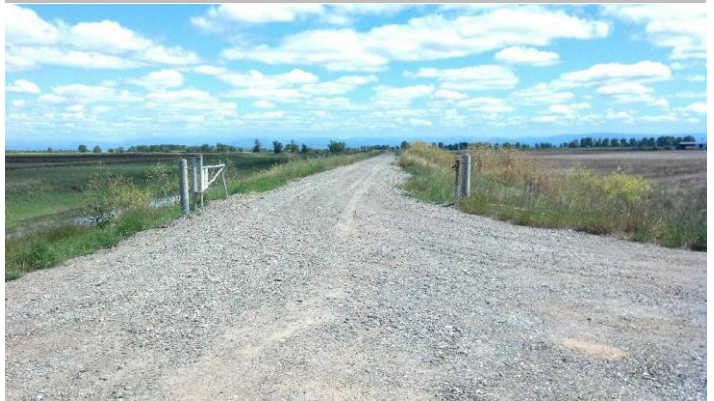
Photo 1 of 3 : UCIP_SP_2019_52170_67462.jpg

Comment Code						
Inspector Comment						
FS_ID:52170 DS_ID:16394 EP_NO: N/A Repair Type: Non-Urgent Crossing Status: Found UCIP Comments: 5/30/2017 WS flap gate showing signs of rusting and deterioration but still appears to be able to function properly. Pipe has been selected to be internally cleaned and inspected as part of the DMP project. (DWR Sutter Yard - A Freitag)11/17/2016 WS flap gate is really rusted and deteriorated but it appears to still function properly. (DWR Sutter Yard - A Freitag)4/26/2016 WS flap gate is really rusted and deteriorated. May need to be replaced. The rest of the crossing appeared in good condition.6/30/2015 Crossing is in good condition. No noticeable issues to be reported.5/28/2014 Same as last inspection.12/4/2013 WS ans LS slopes are in good condition.7/08/2013 Same as last inpection.4/24/2012 Limited inspection on WS and LS slopes due to dense vegetation. Need photos of cleared WS and LS slopes. This crossing was listed in the USACE Periodic Inspection report as Corp's inspect ID# USACE_CESPK_M13E_2011_p_0251 for no outlet visible on WS. FIELD_STRUCT_DESC: 24-inch corrugated metal drainage pipe through the levee, 11.6 feet below the crown. Flap gate on the waterside (WS) end. Concrete "U" headwalls on both WS and landside (LS). Rusted gate located on the WS (gate stuck). [Additional Reference(s): DWR Levee Log, 1993. USACE Sacramento O&M Manual 519, June 1962 (HLM 22.08)] FS Date: 6/8/2017 10:37:02 AM

Overview of crossing looking upstream at the left bank of Cherokee Canal.

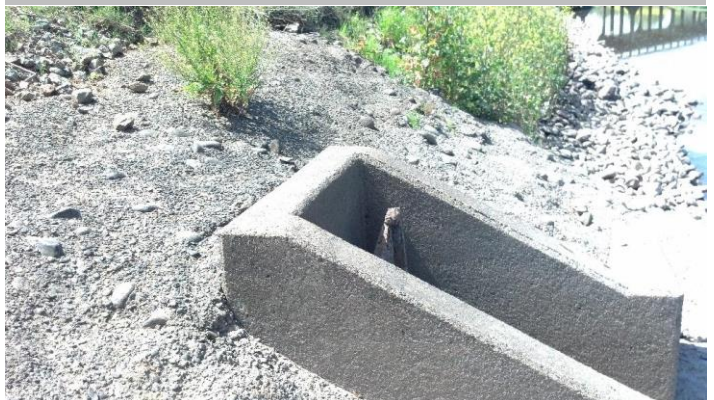
Photo 2 of 3 : UCIP_SP_2019_52170_67460.jpg

View of WS headwall.

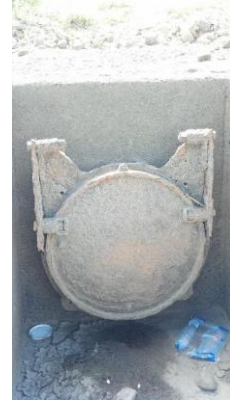
Photo 3 of 3 : UCIP_SP_2019_52170_67461.jpg

Item	DWR UCIP LMA Responsibility			39.362378 °	39.362378 °	
				-121.867350 °	-121.867350 °	
DWR ID	16394					
Comment Code						
Inspector Comment						
FS_ID:52170 DS_ID:16394 EP_NO: N/A Repair Type: Non-Urgent Crossing Status: Found UCIP Comments: 5/30/2017 WS flap gate showing signs of rusting and deterioration but still appears to be able to function properly. Pipe has been selected to be internally cleaned and inspected as part of the DMP project. (DWR Sutter Yard - A Freitag)11/17/2016 WS flap gate is really rusted and deteriorated but it appears to still function properly. (DWR Sutter Yard - A Freitag)4/26/2016 WS flap gate is really rusted and deteriorated. May need to be replaced. The rest of the crossing appeared in good condition.6/30/2015 Crossing is in good condition. No noticeable issues to be reported.5/28/2014 Same as last inspection.12/4/2013 WS ans LS slopes are in good condition.7/08/2013 Same as last inpection.4/24/2012 Limited inspection on WS and LS slopes due to dense vegetation. Need photos of cleared WS and LS slopes. This crossing was listed in the USACE Periodic Inspection report as Corp's inspect ID# USACE_CESPK_M13E_2011_p_0251 for no outlet visible on WS. FIELD_STRUCT_DESC: 24-inch corrugated metal drainage pipe through the levee, 11.6 feet below the crown. Flap gate on the waterside (WS) end. Concrete "U" headwalls on both WS and landside (LS). Rusted gate located on the WS (gate stuck). [Additional Reference(s): DWR Levee Log, 1993. USACE Sacramento O&M Manual 519, June 1962 (HLM 22.08)] FS Date: 6/8/2017 10:37:02 AM

Flap gate located on WS.

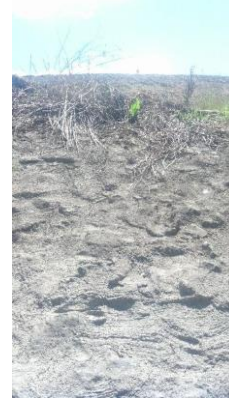
Photo 1 of 3 : UCIP_SP_2019_52175_67498.jpg

Comment Code						
Inspector Comment						
FS_ID:52175 DS_ID:16391 EP_NO: N/A Repair Type: Non-Urgent Crossing Status: Found UCIP Comments: 5/30/2017 Location of LS inlet still unknown. Need to trace with utility locator/GPR to find. Pipe has been selected to be internally cleaned and inspected as part of the DMP project. (DWR Sutter Yard - A/Freitag)11/17/2016 Unable to locate LS pipe end. WS appears to be in good condition. (DWR Sutter Yard - A/Freitag)4/26/2016 Still unable to locate the LS headwall and end of pipe. Pipe is still being used. Pipe was draining to WS.6/30/2015 Still unable to locate the LS headwall and pipe end.5/28/2014 Same as last inspection.12/4/2013 Same as last inspection.7/08/2013 Same as last inspection. Unable to locate LS headwall.4/24/2012 Unable to locate LS headwall. Need photo of LS headwall during next inspection. FIELD_STRUCT_DESC: 30-inch corrugated metal drainage pipe through the levee, 15.3 feet below the crown. Concrete "U" headwalls on both waterside (WS) and landside (LS) ends. Flap gate on the WS end. This pipe runs on an angle through the levee, then underground along the LS slope to historic levee mile (HLM) 22.39 where it enters a ditch on the LS. [Additional Reference(s): DWR Levee Log, 1993. USACE Sacramento O&M Manual 519, June 1962 (HLM 22.41)] FS Date: 6/8/2017 10:42:36 AM

View of WS slope looking from WS headwall to levee crown.

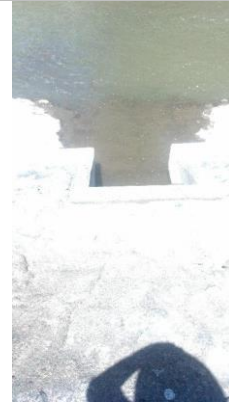
Photo 2 of 3 : UCIP_SP_2019_52175_67496.jpg

View of WS slope looking from WS headwall to levee crown.

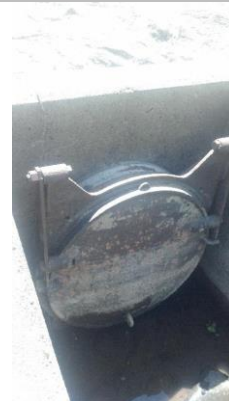
Photo 3 of 3 : UCIP_SP_2019_52175_67497.jpg

View of flap gate on WS.
